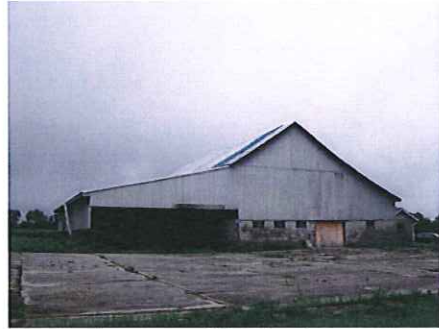
1 Main barn consists of CMU foundation, wood framing/metal siding, metal roof over wood shingle. It is in poor condition with water and structural damage.

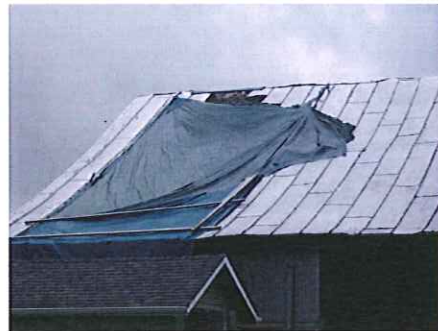
2 Deteriorating roof on main barn. Assume wind damage to metal roof.

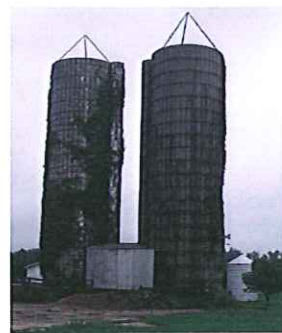
3 Structure consists of reinforced concrete. It is in fair condition. Will acquire additional structural study.

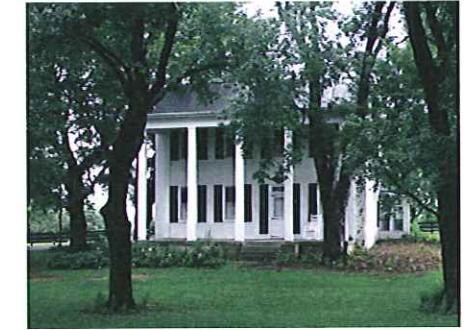
4 Structure consists of wood framing, painted brick, painted wood siding, metal roof. It is in good condition.

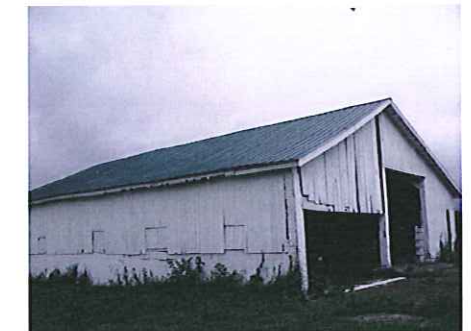
5 Secondary barn consists of CMU foundation, wood framing/siding with metal roof. It is in poor condition with water damage.

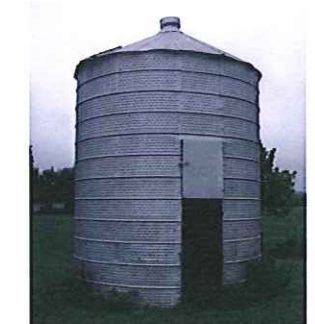
6 Structure consists of steel frame with aluminum wall and roof panel. It is in good condition.
